Subject: The Highlands at Warner Springs
(TM 5450)
Warner Springs area,
San Diego County, California
GEOLOGIC INVESTIGATION

GEOLOGIC INVESTIGATION THE HIGHLANDS AT WARNER SPRINGS SAN DIEGO COUNTY, CALIFORNIA

Subject: The Highlands at Warner Springs
Warner Springs area,
San Diego County, California
(TM 5450)
(Addendum to Report of Geologic Investigation
dated January 23, 2006)

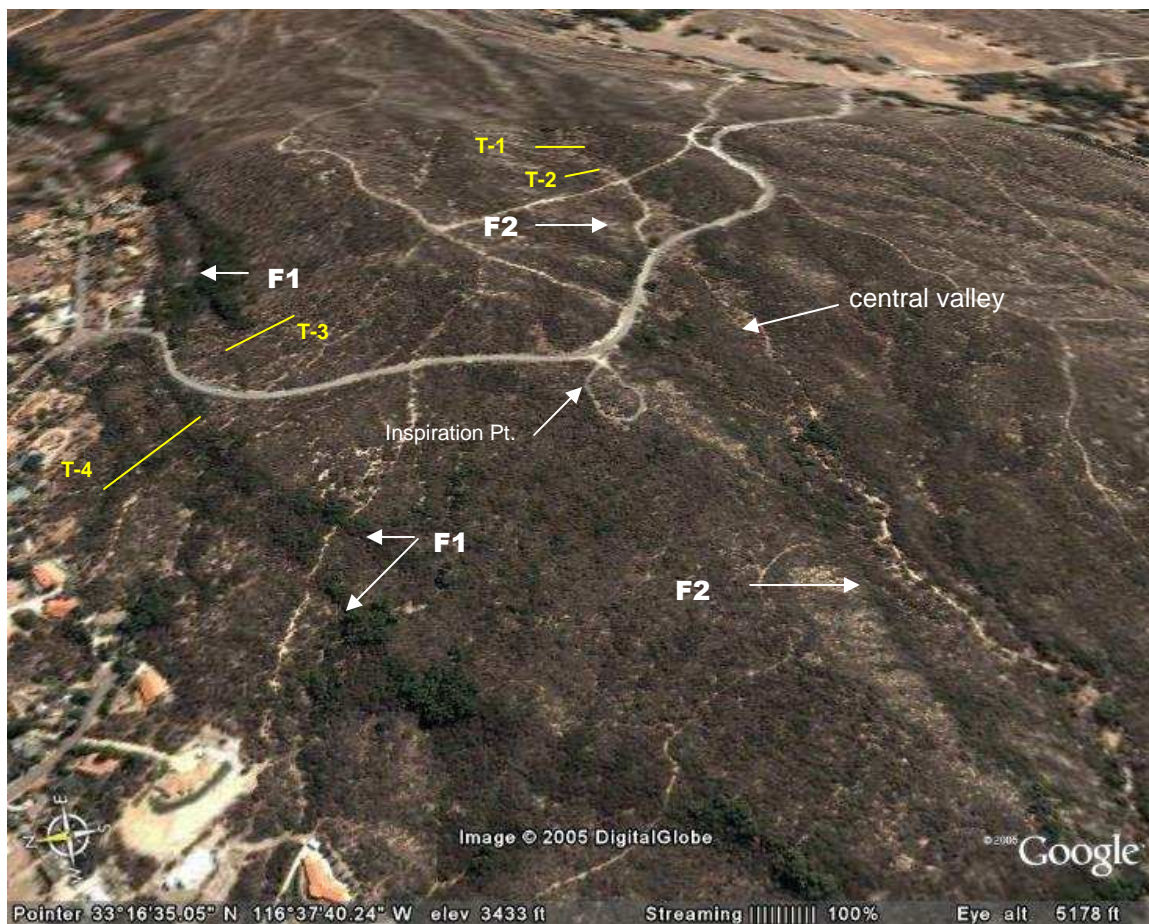
Although there is no evidence that the Aguanga fault is located on or near the site, the review of aerial photographs indicated the presence of very strong east-west to northeast topographic and vegetation lineaments. These lineaments were investigated by trenching and discussed in the following paragraphs.

Figure 3. View to southeast showing major faults manifested by vegetation and topographic lineaments. F1; thrust fault complex; F2, central valley fault.

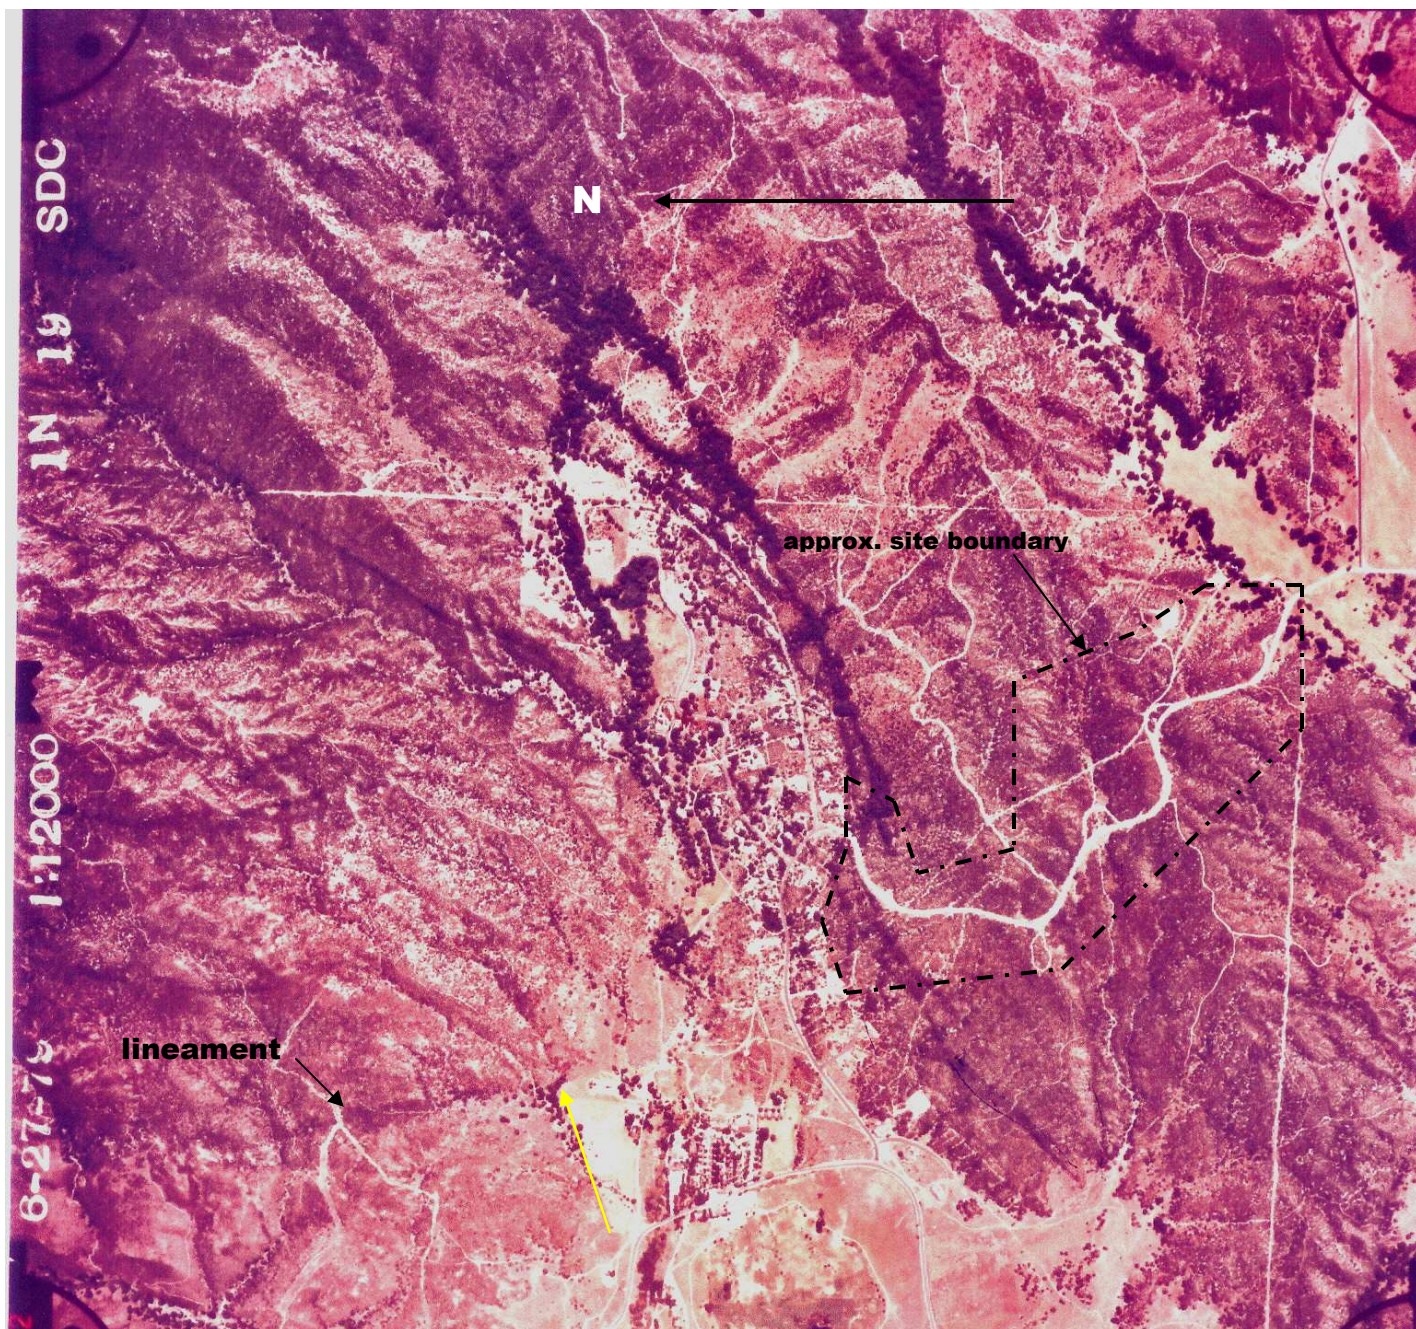
extend as far south as previously mapped. Subtle northwesterly lineaments observed on the San Diego County 1978/79 aerial photographs suggest the fault dies out to the north before reaching the vicinity of the site (Figure 3a). Slip on the fault is likely transferred to the south branch of the fault located approximately 1.5 miles to the west or the Agua Tibia fault located 3 miles west (Figures 1 and 2).

Figure 3a. Possible location of Aguanga fault north of site. Discontinuous vegetation lineament terminates at tip of the yellow arrow prior to reaching vicinity of site. (ref. photo: County of San Diego, 1978/79, Flt.1N, 19)

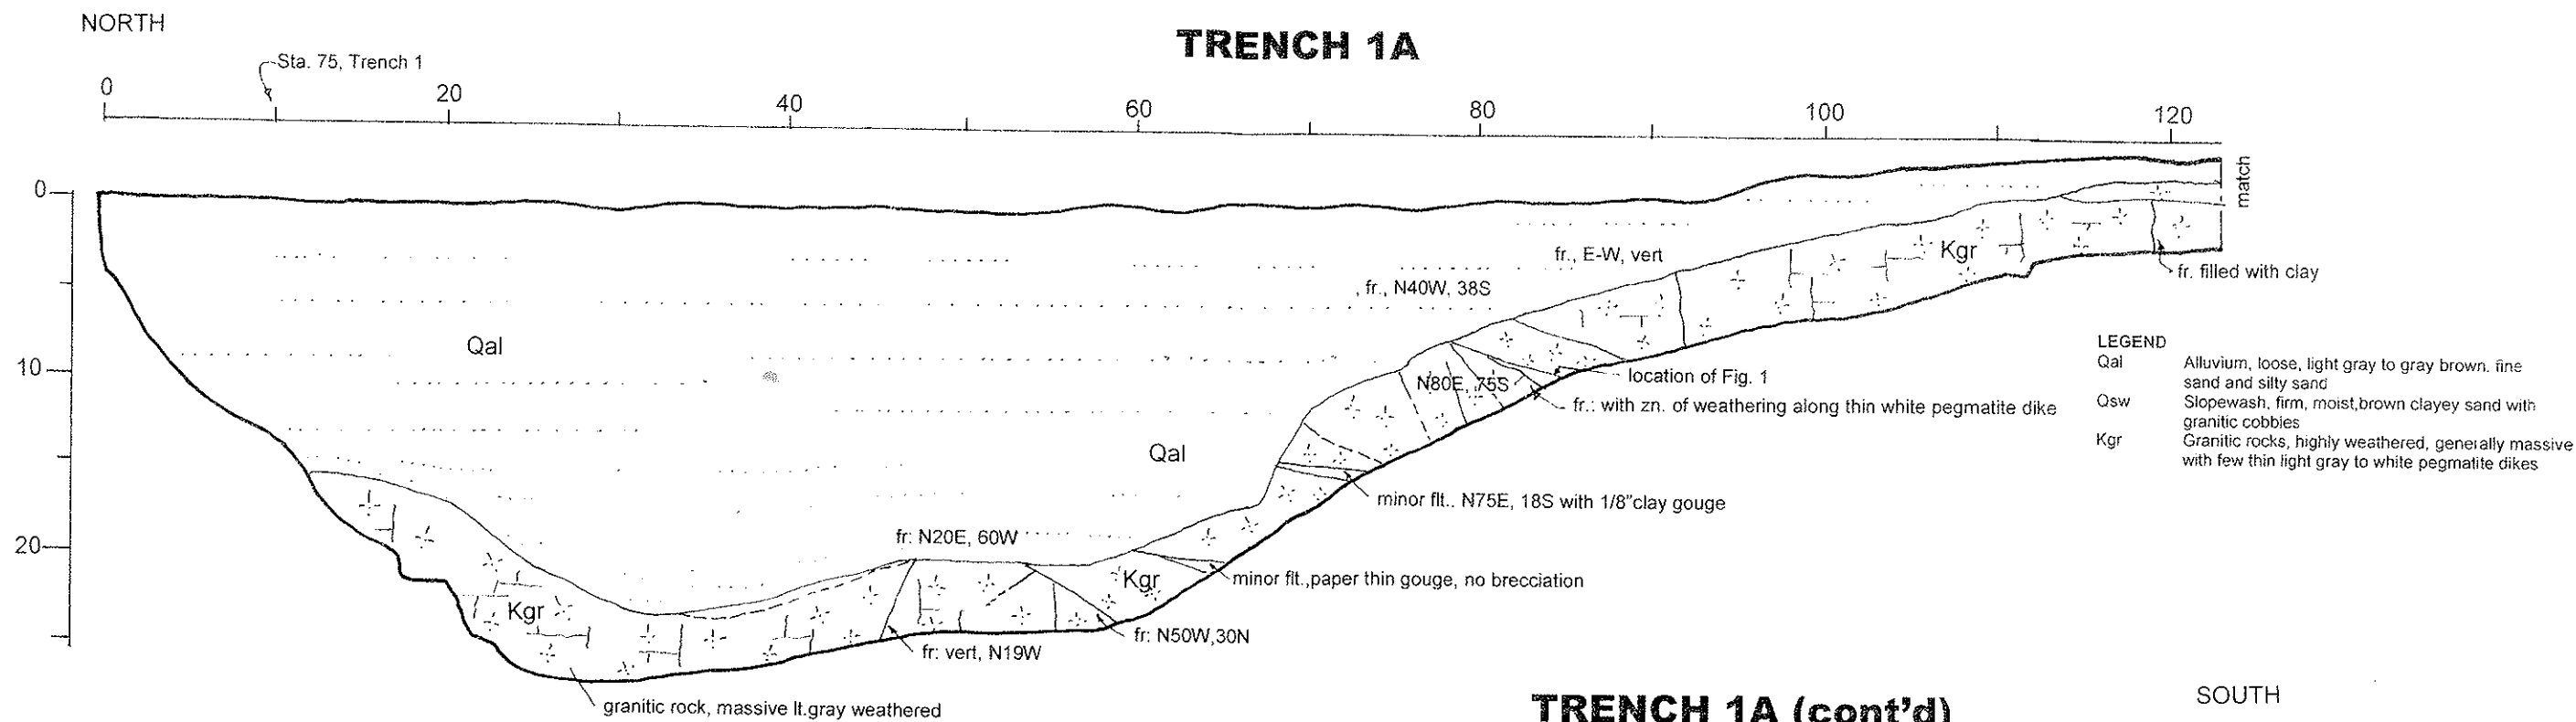
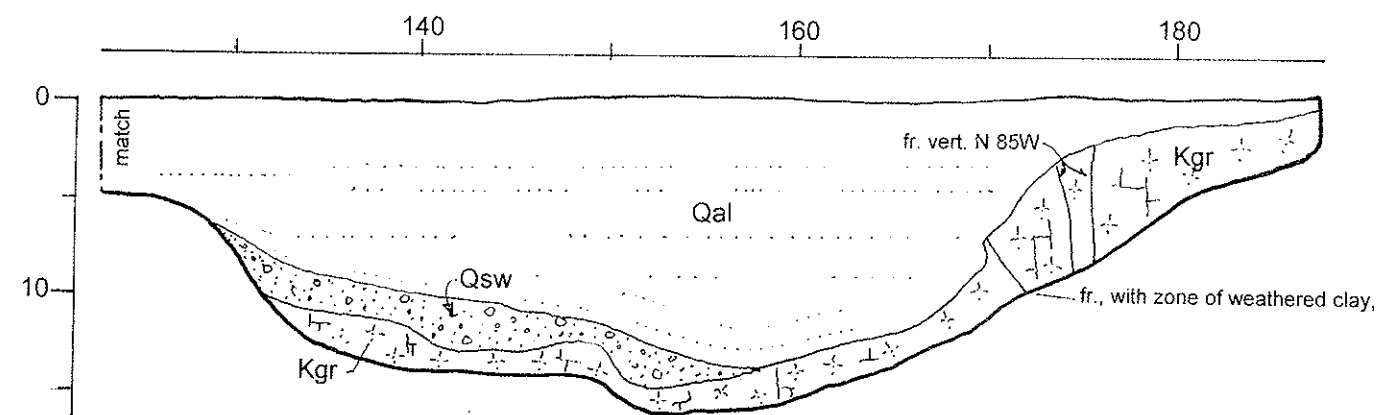
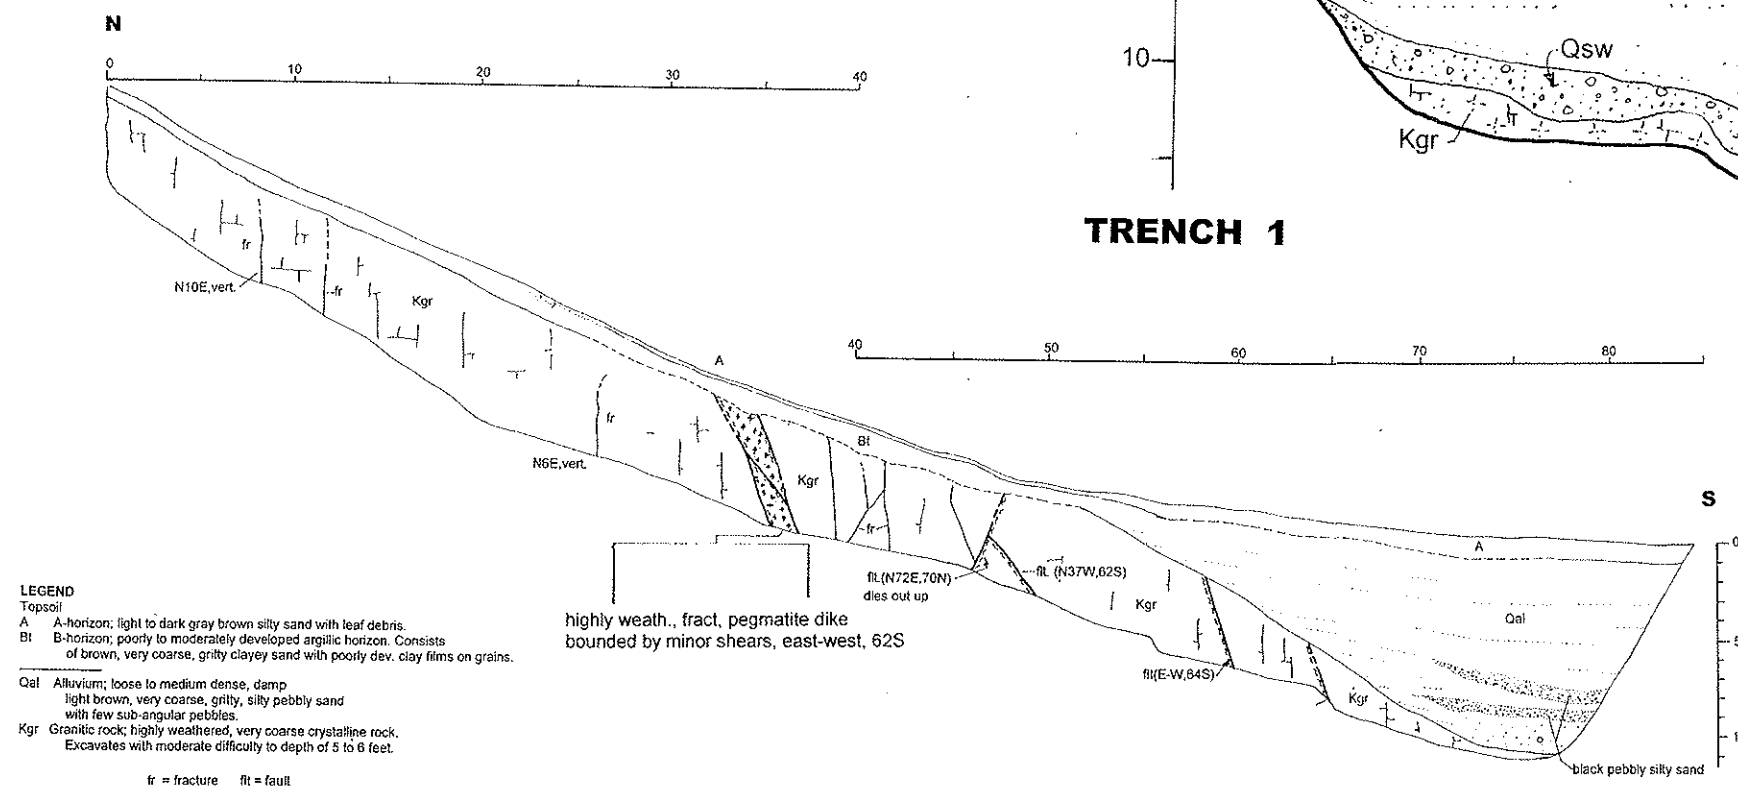
Plate 2

Trench 1: Trench 1 was approximately 85 feet in length and is located on the north side of the Central Valley near the east property line (This trench was extended as Trench 1A during the preparation of the Appendix included at the back of this report for a total length of approximately 185 feet). Trench 1 trench encountered several east to northeast trending, south-dipping, normal faults located on trend with the most northerly of two parallel lineaments observed in the eastern portion of the valley. The faults are manifested by well-developed clay gouge and shear surfaces along with locally developed thick zones of white thoroughly pulverized rock (rock flour). The faults do not offset topsoil or the thick alluvium located in the southern portion of the trench determined to have a radiocarbon age of 3970 yrs. by Beta Analytic Inc.(2006).

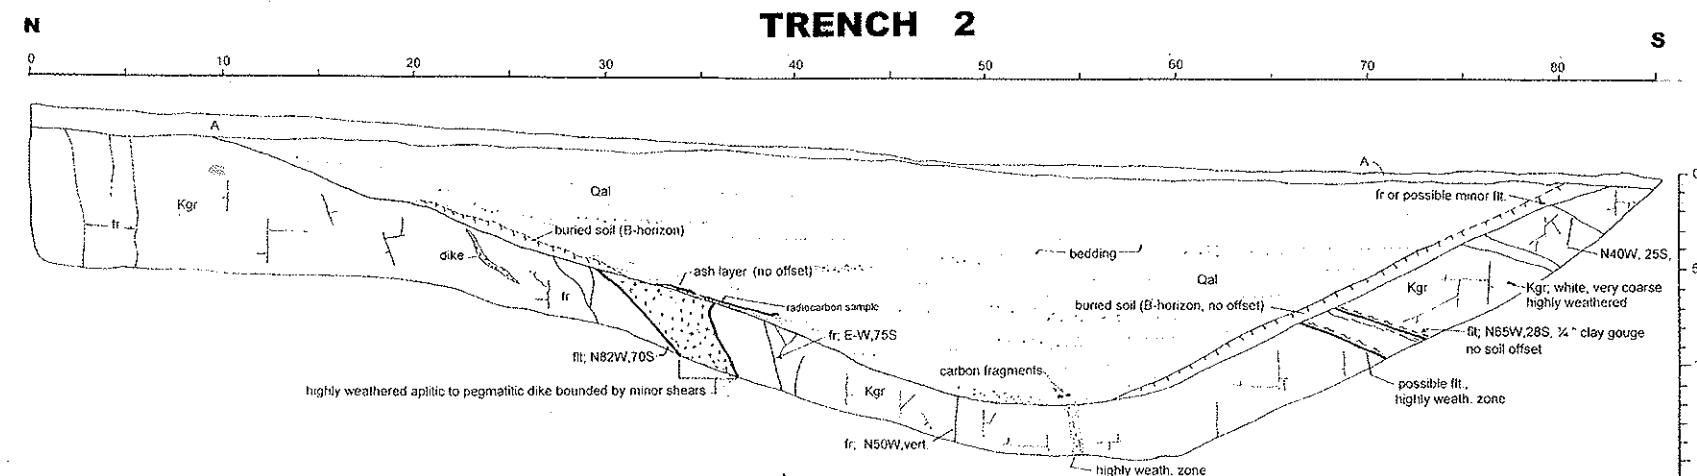
TRENCH 2 WARNER SPRINGS ESTATES
Warner Springs Area, San Diego County, California

Trench 2: Trench 2 is located 360 feet west of Trench 1 to further define the location of the faults encountered in Trench 1 and to attempt to obtain datable material for determining the age of faulting. This trench was also 85 feet in length and encountered the same fault zone exposed in Trench 1. The most significant fault is located at Station 30 to 35 and is accompanied by 3 to 4 feet of pulverized rock bounded by two northeast trending, south-dipping fault planes. The fault zone is overlain by an unfaulted detrital charcoal layer correlated with a similar charcoal layer present in T1 determined to have an age of approximately 3970 yrs.

Relatively minor faults, as judged from the thin clay gouge and lack of significant thickness of adjacent shearing, are located between Stations 55 to 80. These faults are overlain by a thin buried B-horizon preliminarily estimated to be early Holocene to Late Pleistocene in age based on the relative development of the soil.

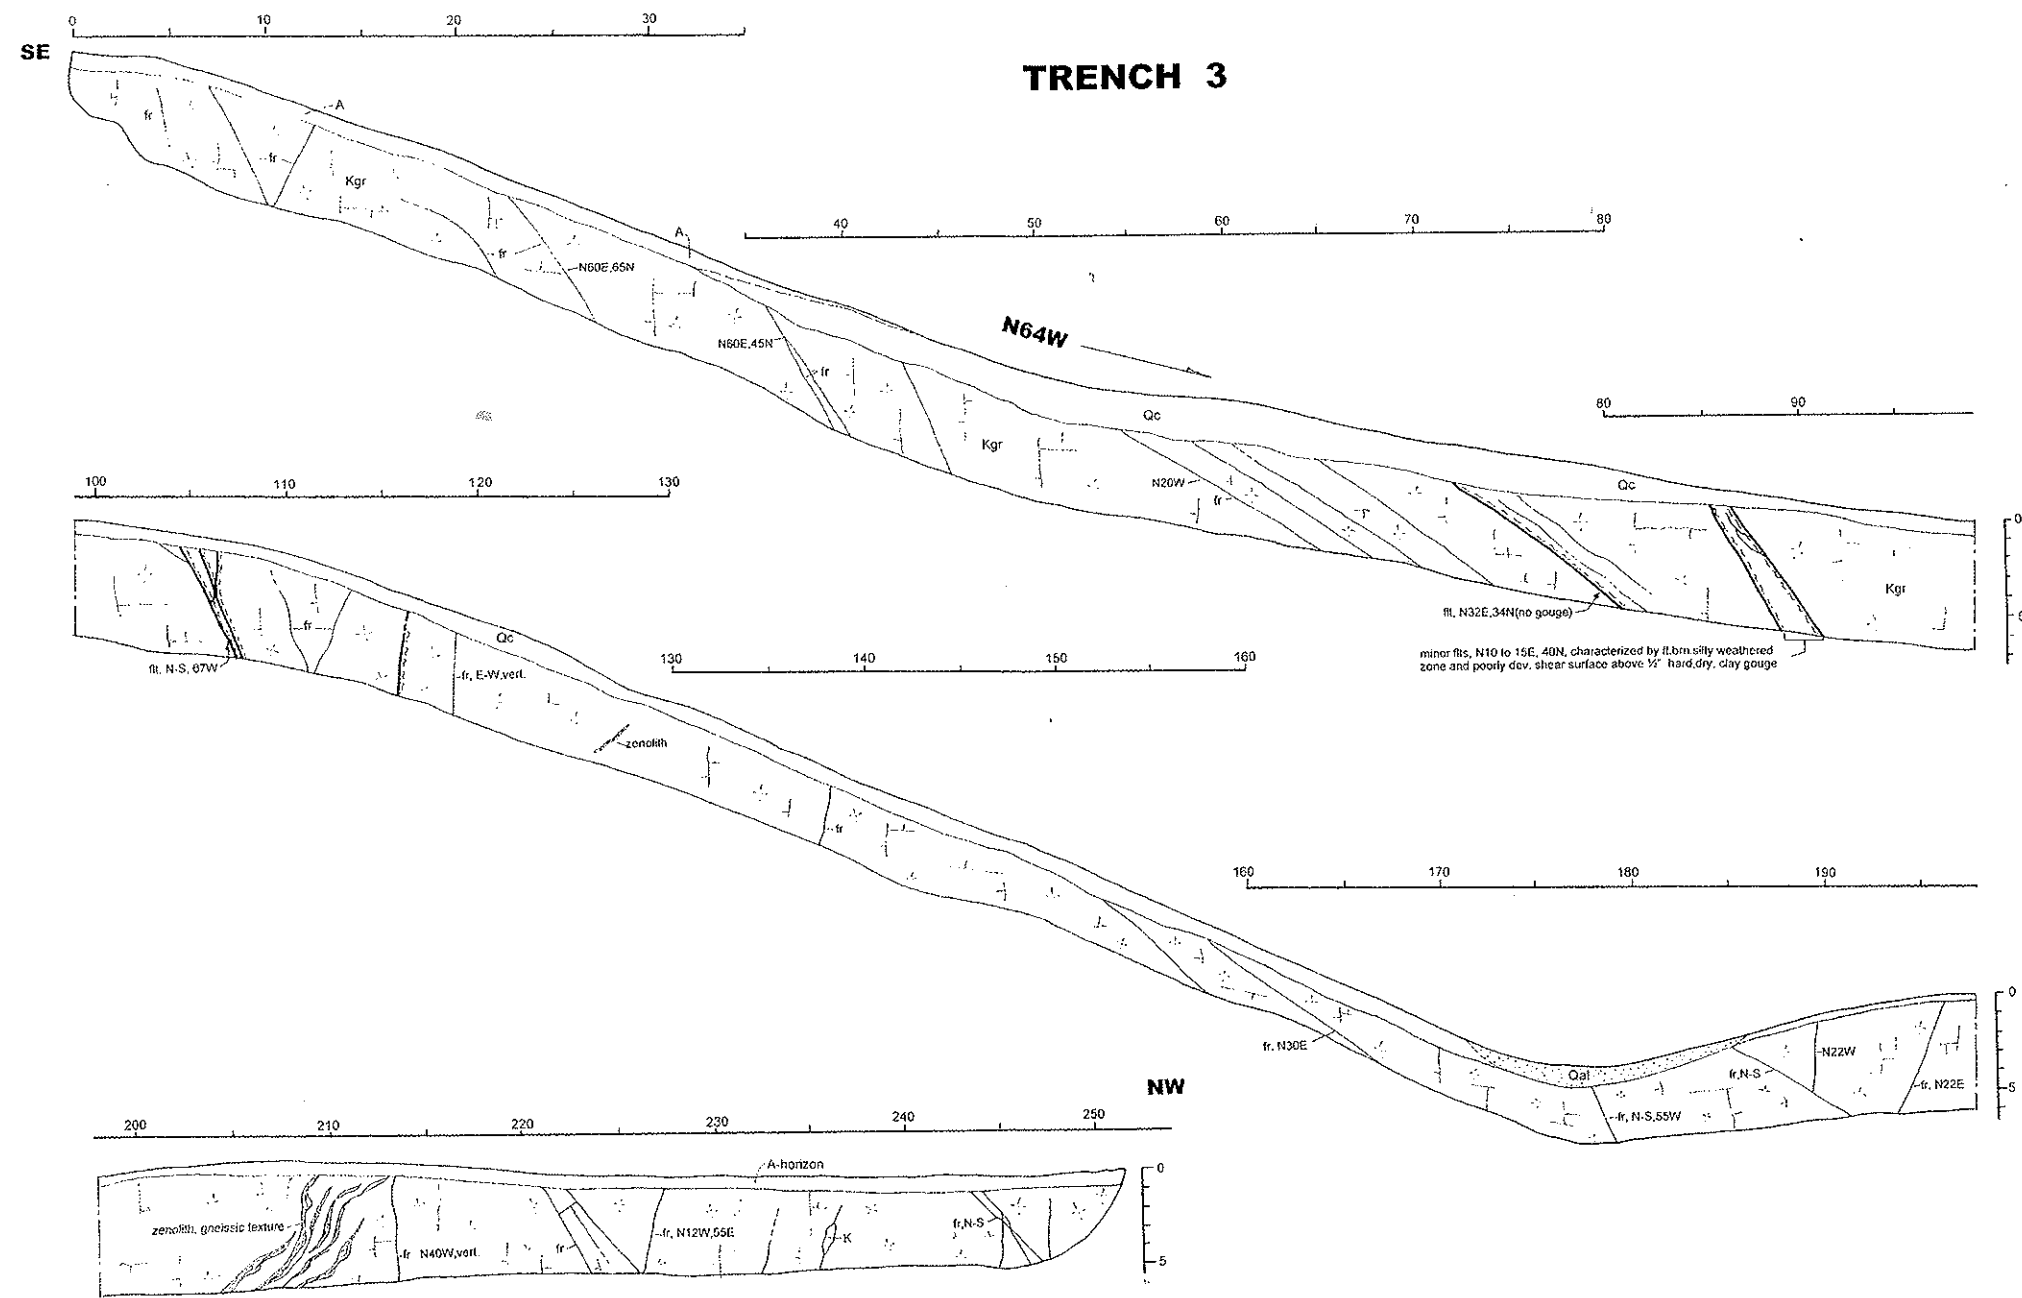
TRENCH 3 WARNER SPRINGS ESTATES Warner Springs Area, San Diego County, California		
SCALE: 1" = 10'	APPROVED BY:	DRAWN BY
DATE: Jan. 2006		REVISED 6/06
MICHAEL W. HART, ENGINEERING GEOLOGIST P.O. Box 261227 • SAN DIEGO • CALIFORNIA • 92196 • (858)-578-4672		DRAWING NUMBER Plate 4

Trench 3 was approximately 252 feet in length and oriented in an east-west direction across the above described northeast lineament. Trench logging confirmed the presence of several low to high-angle, north to northeast trending faults consistent with the location of the lineament observed on the aerial photographs. The faults are characterized by poorly developed gouge zones, generally poorly developed shear planes, and in addition, lack the wide zone of shearing and pulverized rock observed along faults in Fault Zones 1 and 2. It is concluded, therefore, the fault is a minor fault that likely dies out within a few hundred feet south of the trench. Since the faults lack significant gouge and shear fabric and generally trend to the northeast as opposed to the northwesterly trend of the Aguanga fault, it is further concluded that this relatively minor fault system is not related to the Aguanga fault zone.

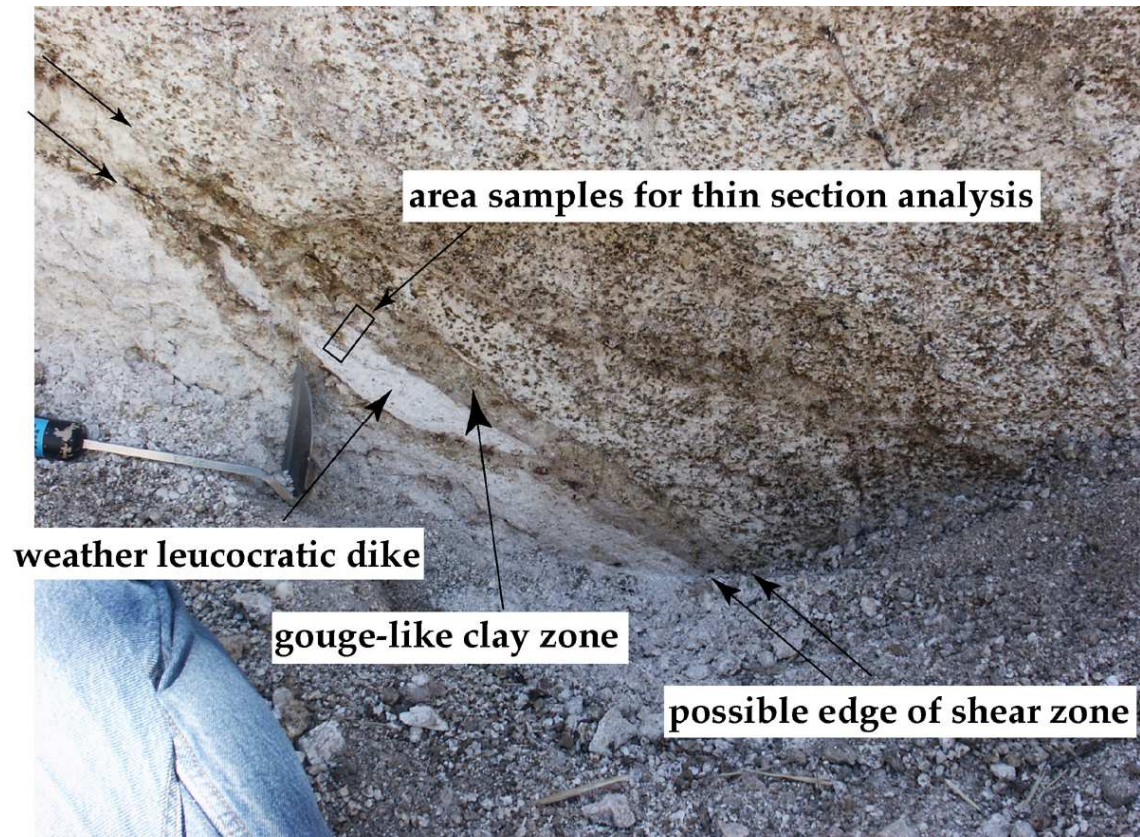
The main feature exposed in trench T-1 appears to be a weathered white leucocratic dike at Station 85 that may have sustained minor shear along its' margins, based on field observations (Figure 1). The similar but thicker dike observed at Station was also bordered by shears that were less prominent than at Station 85 and were not sampled. We could identify domains within the dike where alteration was considerably less, and where quartz and feldspar crystals could be easily discerned. In these cases, it was clear that little or so shear had occurred, at least in these portions of the dike. The fabric and mineralogy of the least weathered parts of the dike support our interpretation of its igneous origin.

Figure 1. Annotated photograph of the dike and shear-like feature in trench T-1, location 85.

In the most intensely weathered portions, the original mineral and intrusive fabric is completely degraded, and is now expressed as a gouge-like tabular zone of clay. To test whether this zone has sustained shear, we collected samples through and across the tabular clay zone and its contact with the host granite. We then cut thin sections for petrographic analysis.

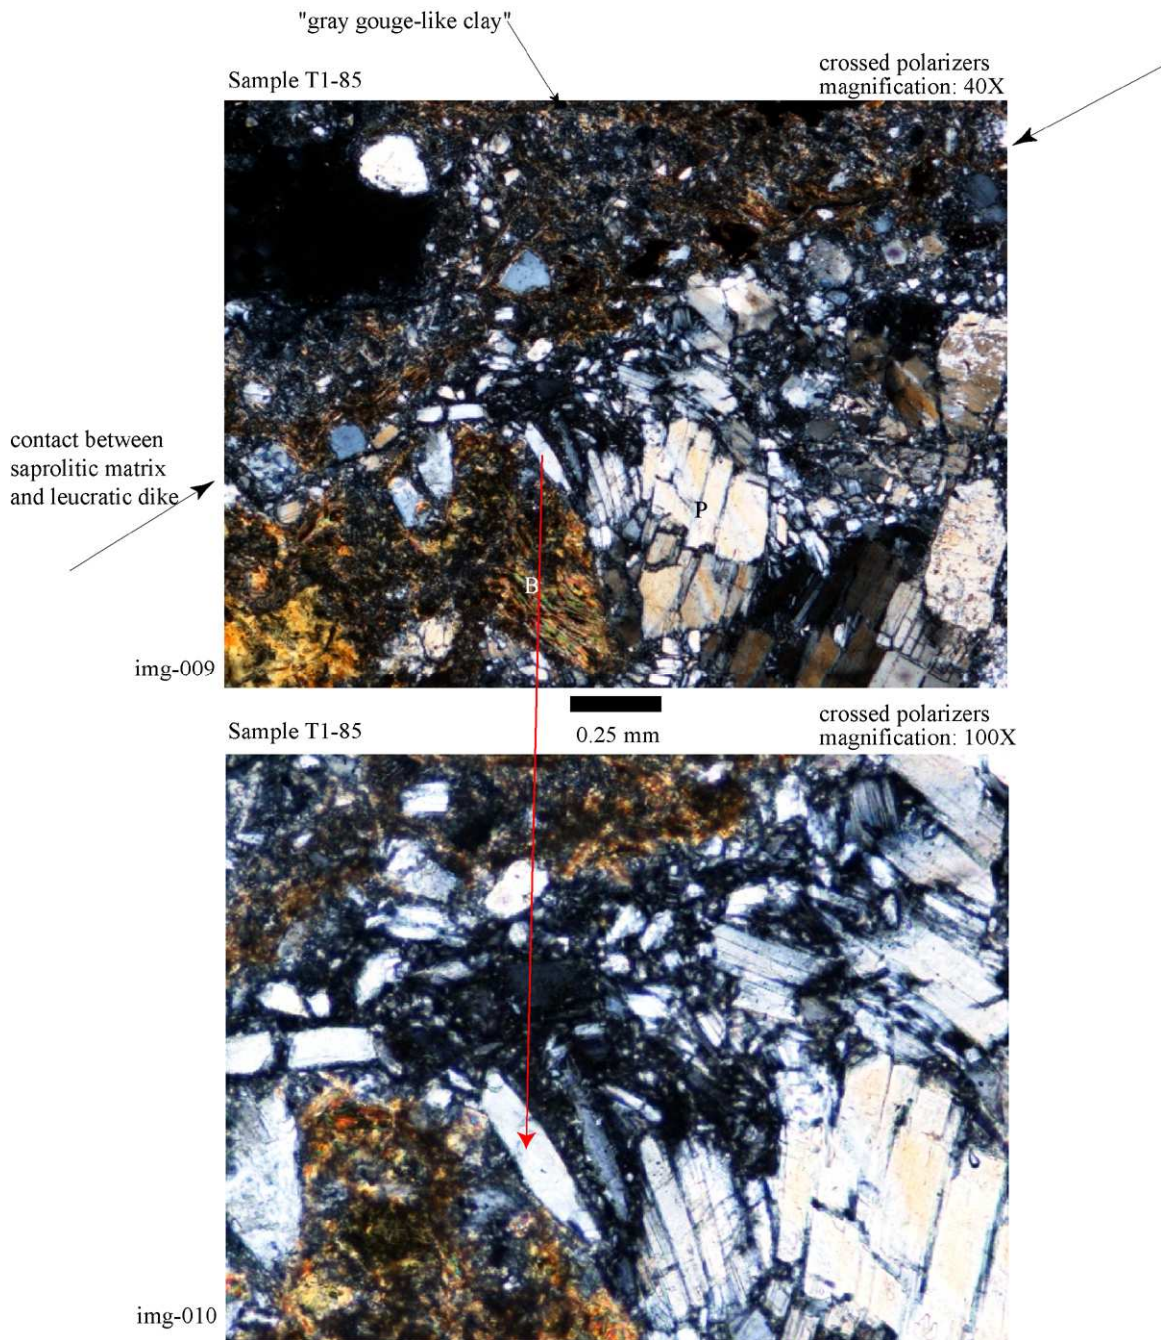
In the photomicrographs shown in Figure 2, taken from across the inferred shear contact, we observe abundant clay but no evidence of brittle shear. The clay appears to have been generated by in situ weathering, and fragmentation of grains through expansion and contraction of clay material. If recent shear had occurred, we would have expected alignment of clay particles and microscopic seams of angular, brittly-fragmented quartz and feldspar. None of those features are evident.

Figure 2. Photomicrograph of the sample collected across the possible shear exposed in T-1 at station 85.

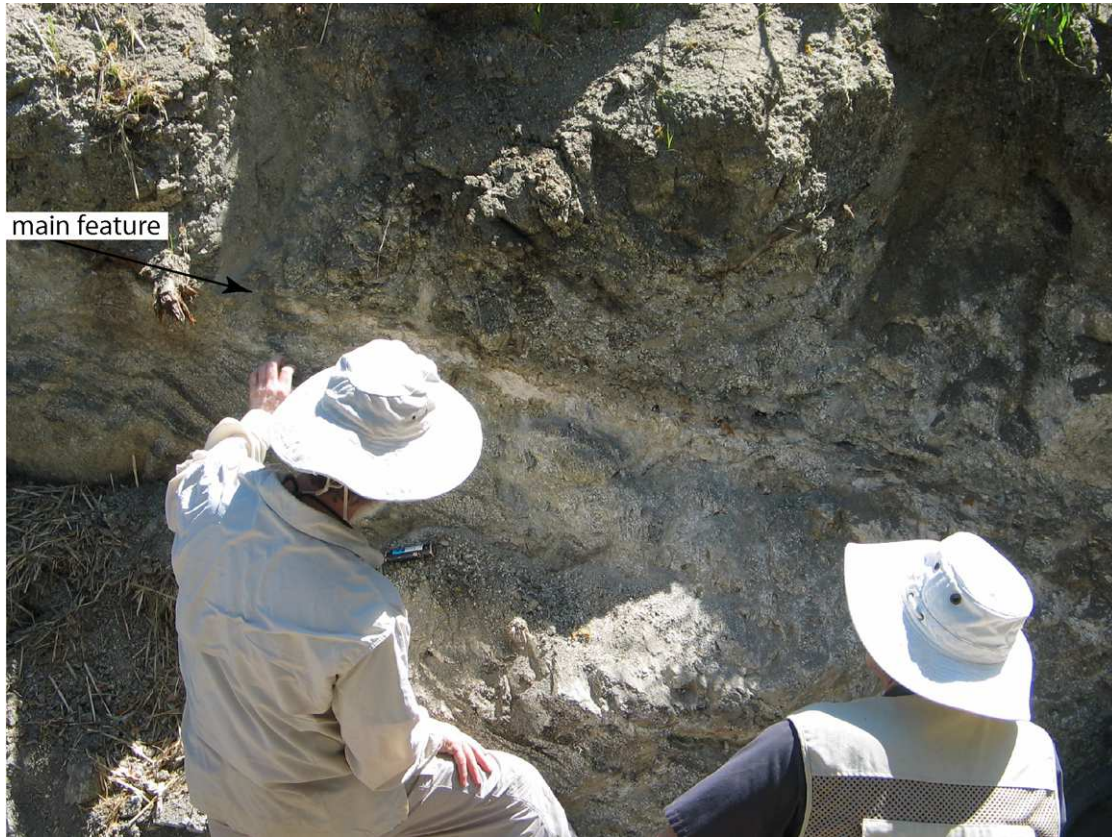
Figure 3. Possible shear exposed at station 85 in trench T-4. The white band is the coarse-grained dike which is locally quite weathered. The gray clay above the white zone is the possible shear.

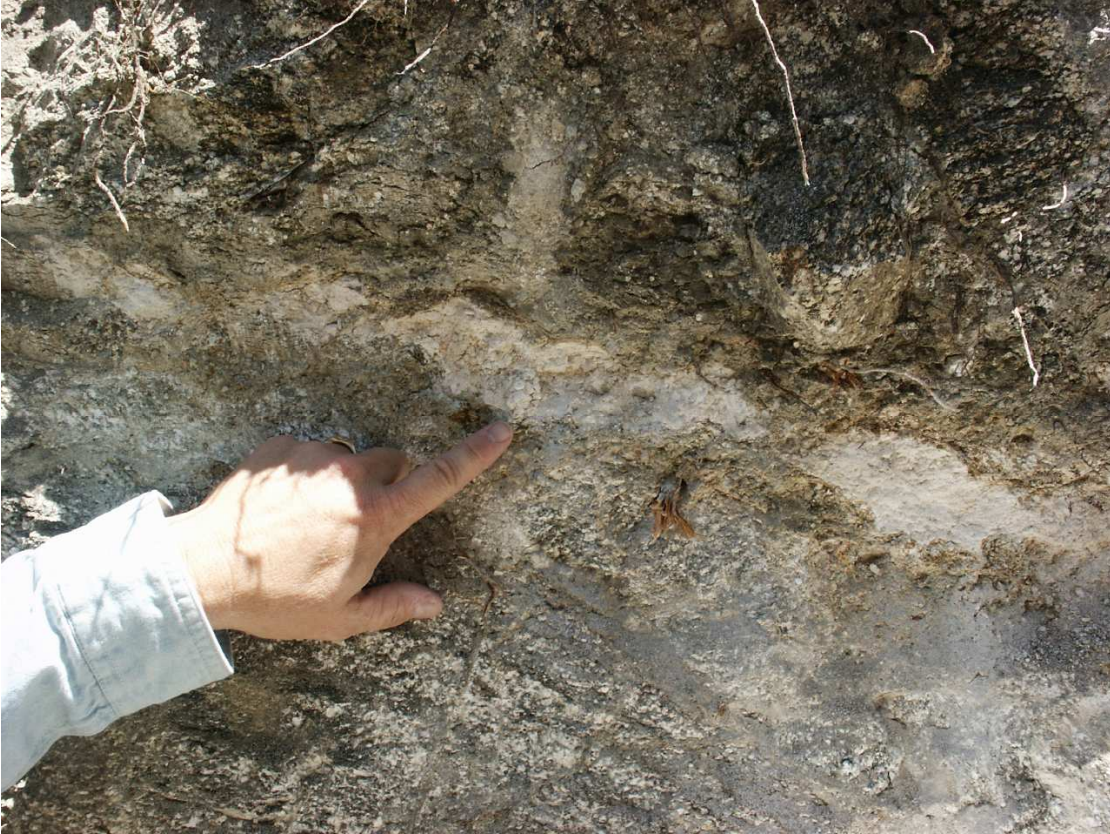
Figure 4. Detail of the dike and gray clay at station 85. The dike is locally extensively weathered.

At station 85, a similar feature is exposed which is also bounded by a pegmatite at its base. The pegmatite measures 2-4 cm thick, with crystals up to 1 cm in size. Above this coarse-grained phase is much finer grained and highly weathered material, appearing similar to the clay seam at station 85. We could discern no evidence of shear, although there are parting surfaces lined with pedogenic clay. Much of the dike appears weathered to kaolinite, with residual quartz crystals.

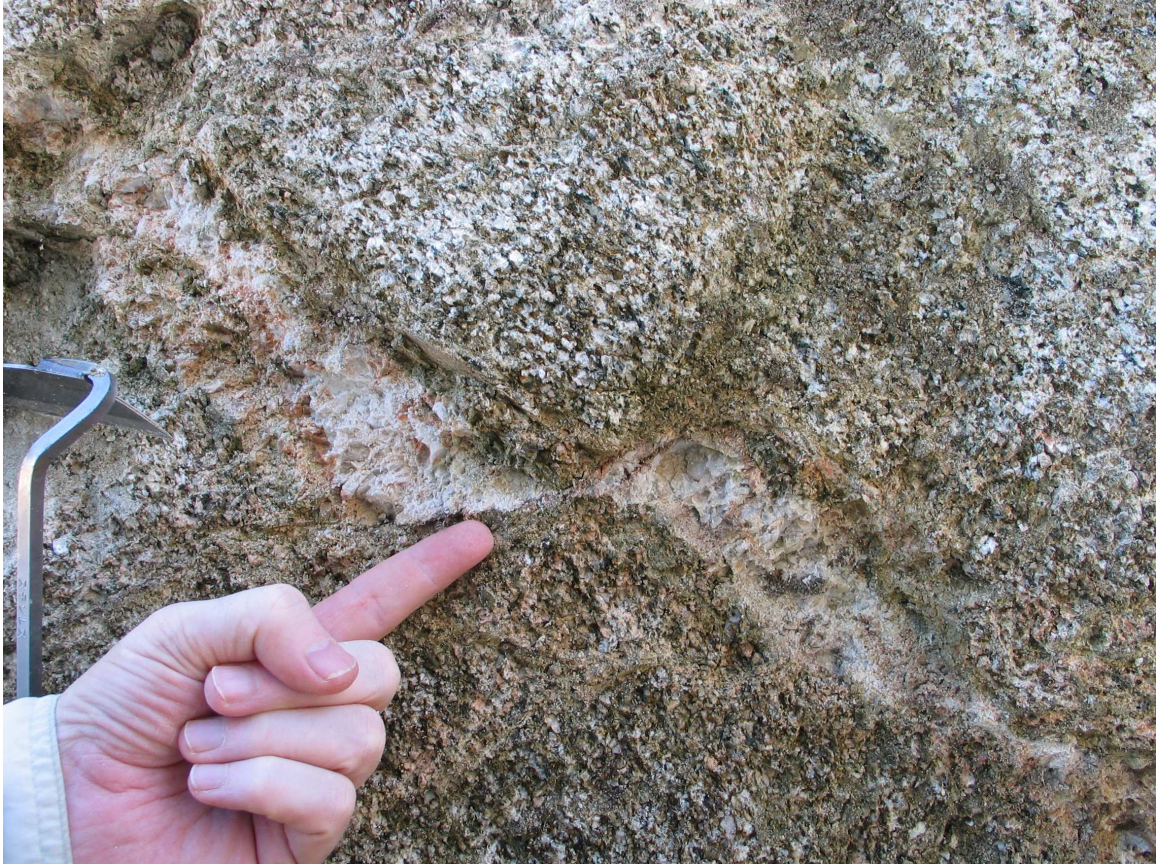
Again, there are two issues here. Could the dike have sustained some relative motion (minor faulting) and, if so, is it potentially active. Two observations clearly bear on this matter. First, the dike is itself offset by a few cm across a joint (Figure 5) near the base of the trench, indicating that if minor motion had been sustained along the dike, then it must have occurred prior to regional uplift and the formation and minor motion on the joint surface (this is common in the Peninsular Ranges). Further, the dike itself is much less weathered at the base of the trench at station 50 and loses its fault-like appearance with depth (Figure 5).

Figure 5. Pegmatite dike and overlying gray clay exposed in trench T-4, offset by minor motion along a joint. Minor differential motion on joints is common in the Peninsular Ranges and is presumed to have occurred during regional uplift during the late Cretaceous.

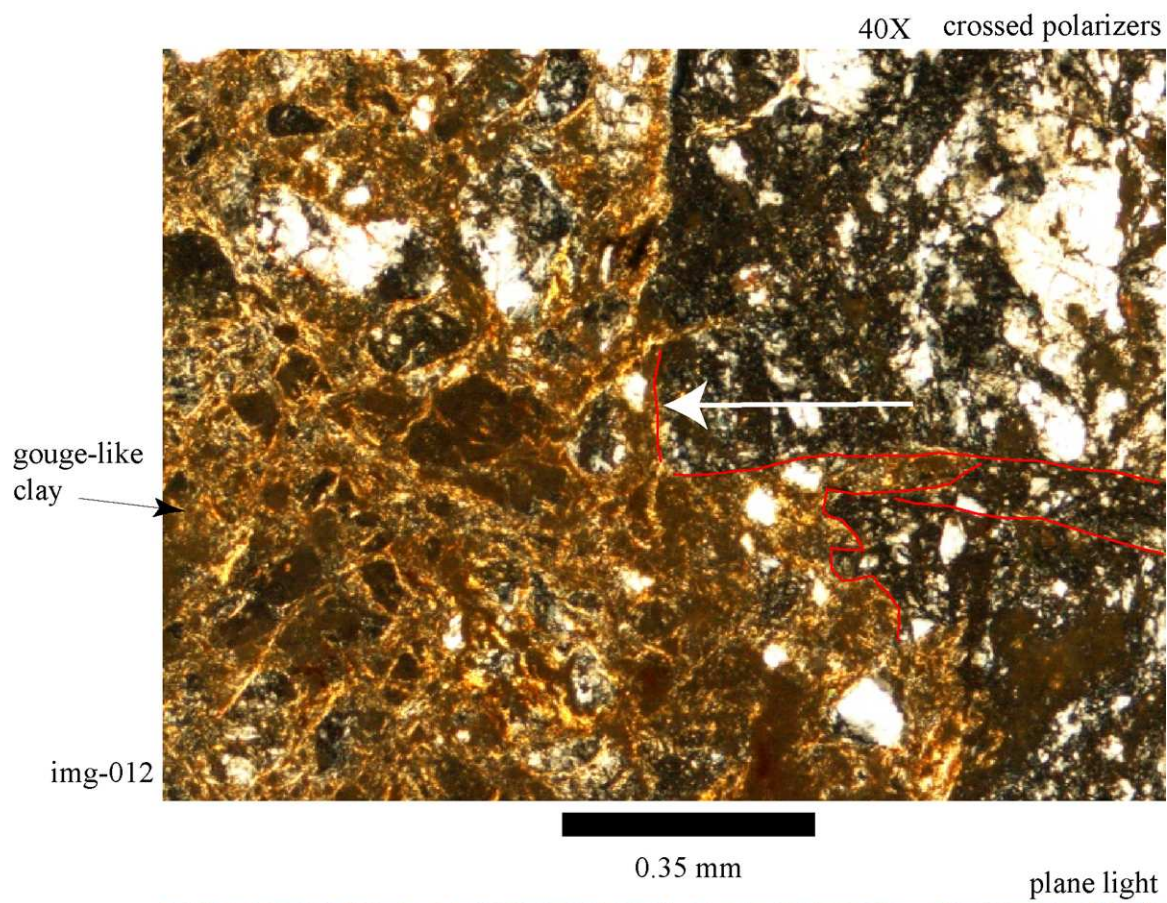
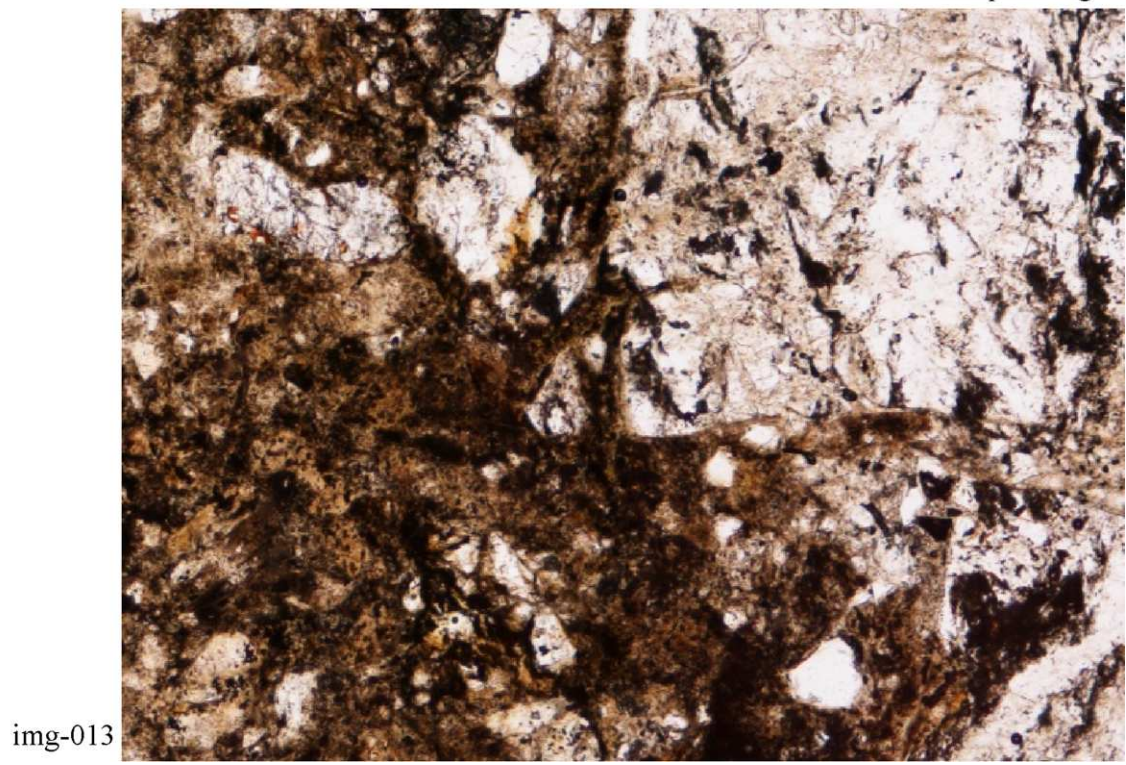
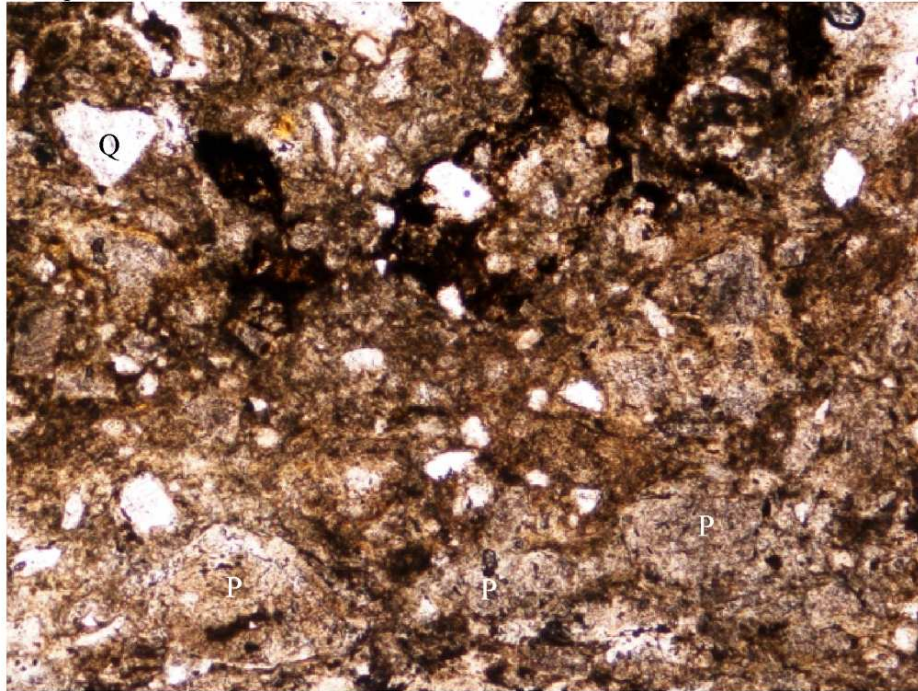
To test this further, we collected samples for thin-section analysis from both features in trench T-4 to resolve whether there is evidence of shear at the microscopic level. Figure 6 is a photomicrograph of the weathered dike at station 85 in trench T-4. The gouge-like material is in situ weathered clay and there is no expression of brittle shear. One grain (outlined in red) appears offset, but cannot be displaced more than a half millimeter. In contrast, there is abundant evidence of in situ fragmentation and weathering with no observable displacement.

Figure 6. Photomicrograph of the weathered pegmatite dike material.

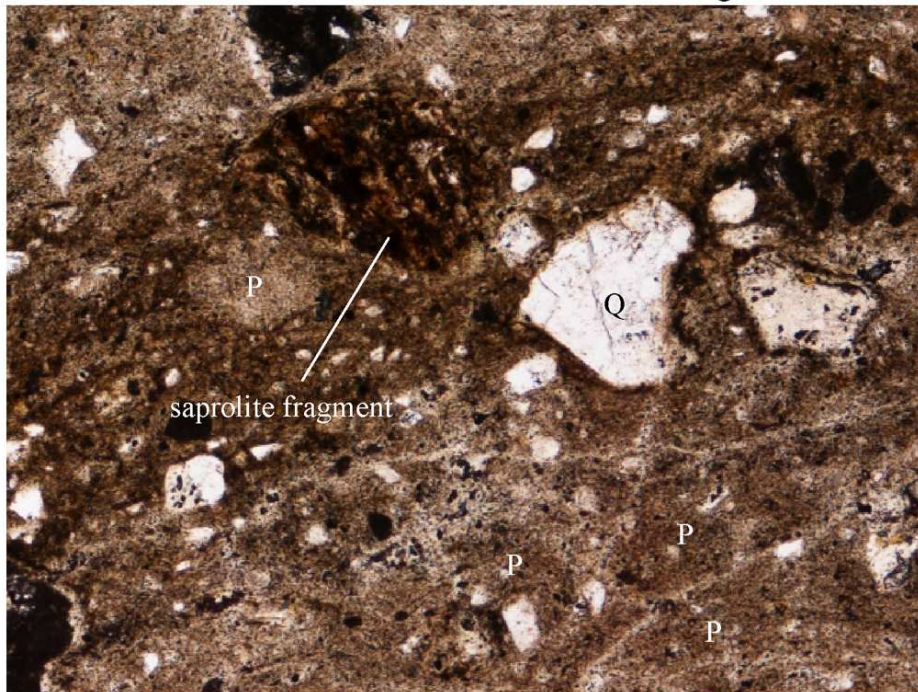
Figure 7 is a photomicrograph taken from the same sample as that in figure 6, but across the possible gouge and shear zone. In this image, there is abundant clay with no preferred orientation that would be indicative of shear. In contrast, there are abundant grain fragments and ghosts of plagioclase that clearly have not been sheared or granulated but display a high degree of weathering. Again, there is no evidence of shear expressed across the clay seam, either at the macroscopic or microscopic level.

Figure 7. Photomicrograph of the possible gouge at station 85 in trench T-4. Note the absence of shear, in spite of the abundant clay.
